# *TNCAL Inspections, LLC*

## Property Inspection Report

, Plumas Lake, California 95961  
Inspection prepared for:  
Real Estate Agent: -

Date of Inspection: 4/18/2024 Time: 1300  
Age of Home: 0 Size: 1852  
Weather: Sunny 77 degrees

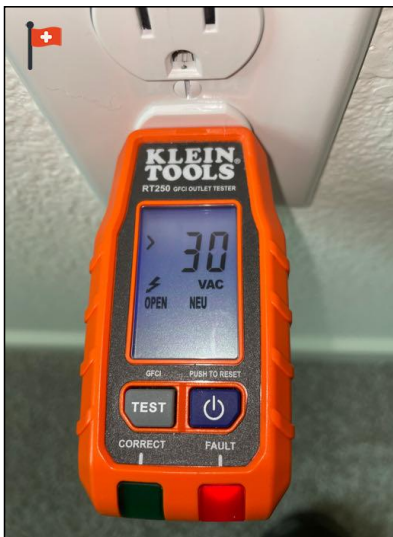
Page 9 Item: 1

Incorrect wiring on receptacle in Bedroom 2. Client should note that every light switch and receptacle in the structure and outside was tested for functionality and found to operate as designed, except for this specific receptacle. Recommend builder electrician repair/replace as necessary.

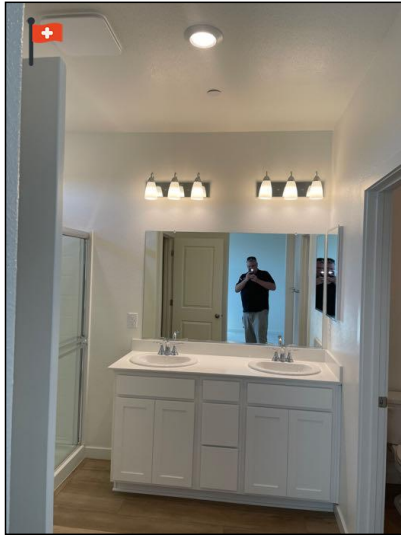
Page 11 Item: 1 Electrical

MBR Bathroom. See additional photo and caption regarding incorrect placement of receptacle near the shower.

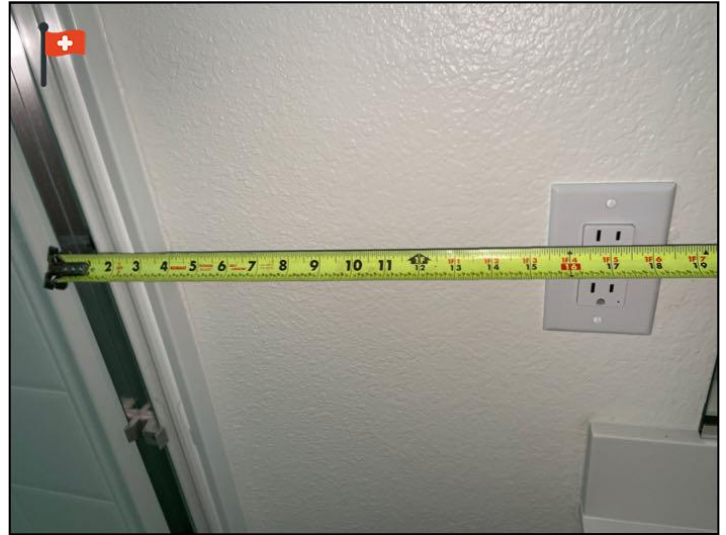
Both the 2020 and 2023 National Electric Code (NEC) 406.9 states that electrical receptacles can be no closer than 3 feet (36 inches) from a tub or shower. While there are four known exceptions, there are none for this type of installation. This is a significant shock/electrocution safety hazard due to its proximity to the shower. Unless a valid exception can be located within the NEC or California electrical code, builder electrical contractor must remove this receptacle, de-energize and/or remove any associated branch wiring, and properly patch the hole remaining in the wall. Recommend follow up to ensure that if the receptacle is re-located, it is done so following the NEC Code.

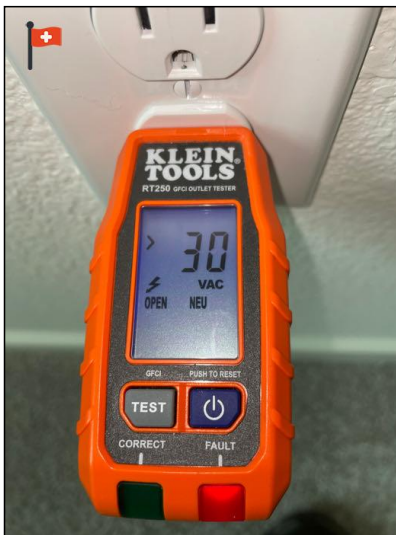
## 1. Electrical

Incorrect wiring on receptacle in Bedroom 2. Client should note that every light switch and receptacle in the structure and outside was tested for functionality and found to operate as designed, except for this specific receptacle. Recommend builder electrician repair/replace as necessary.

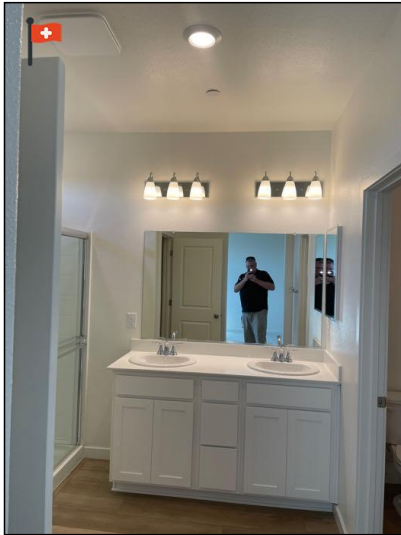
## 1. Electrical

MBR Bathroom. See additional photo and caption regarding incorrect placement of receptacle near the shower.

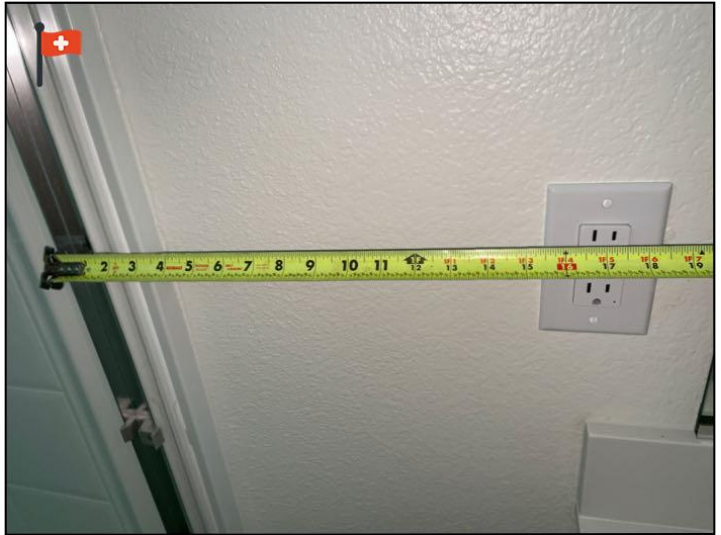
Both the 2020 and 2023 National Electric Code (NEC) 406.9 states that electrical receptacles can be no closer than 3 feet (36 inches) from a tub or shower. While there are four known exceptions, there are none for this type of installation. This is a significant shock/electrocution safety hazard due to its proximity to the shower. Unless a valid exception can be located within the NEC or California electrical code, builder electrical contractor must remove this receptacle, de-energize and/or remove any associated branch wiring, and properly patch the hole remaining in the wall. Recommend follow up to ensure that if the receptacle is re-located, it is done so following the NEC Code.

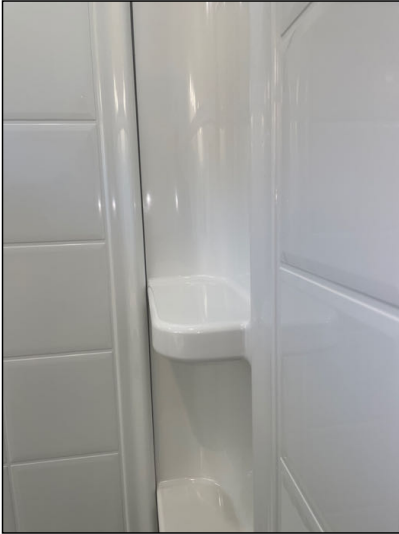
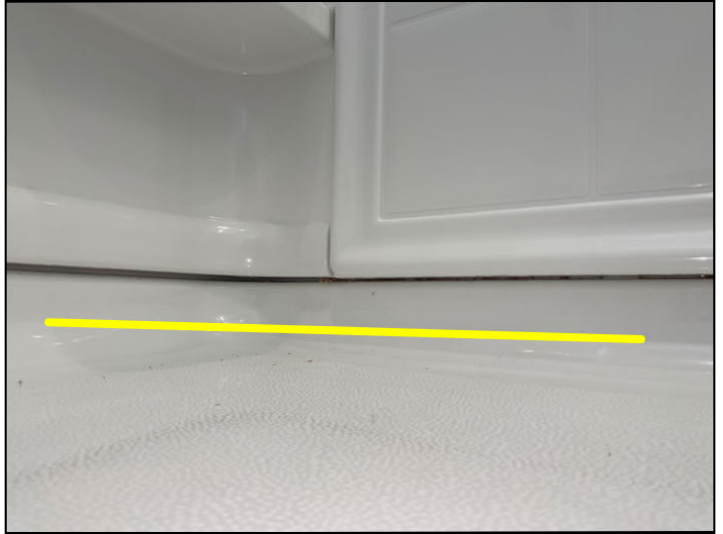
## 2. Shower Walls

The shower walls were not caulked and sealed to prevent moisture intrusion. While this is a concern, some manufacturers recommend not caulking the seams in the shower panels. It is not known to the inspector who manufactured the shower panels in the bathroom showers.

Recommend review by builder and follow manufacturers instructions regarding the proper sealing of the joints in shower panels. See other pics also.

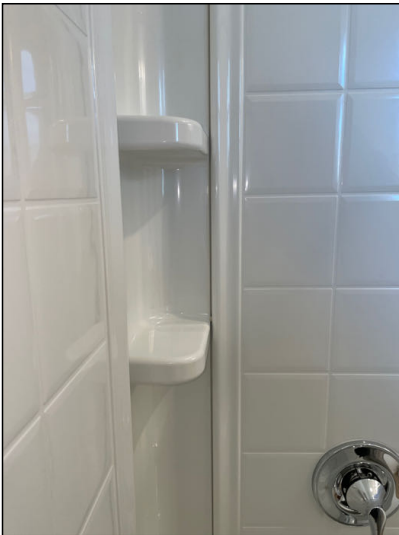
Bthrm 2 Shower walls.

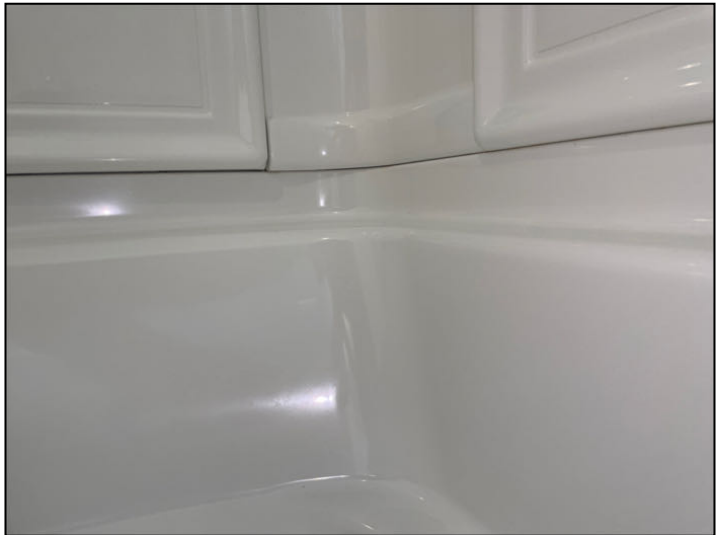
Bthrm 2 Shower walls.

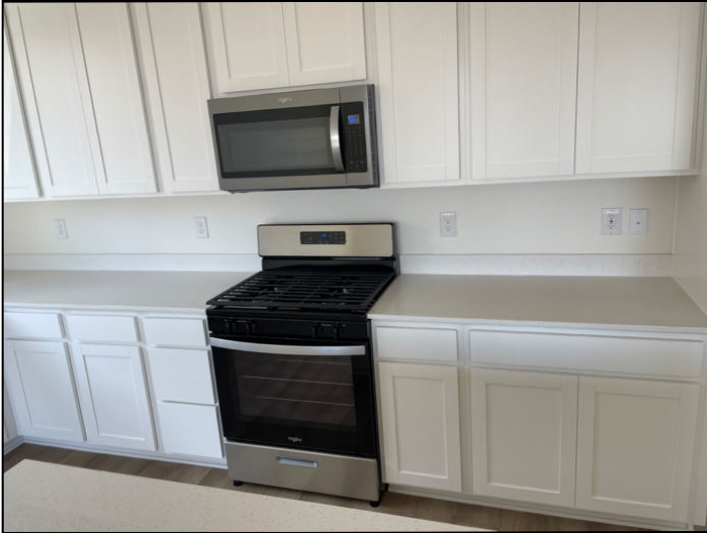
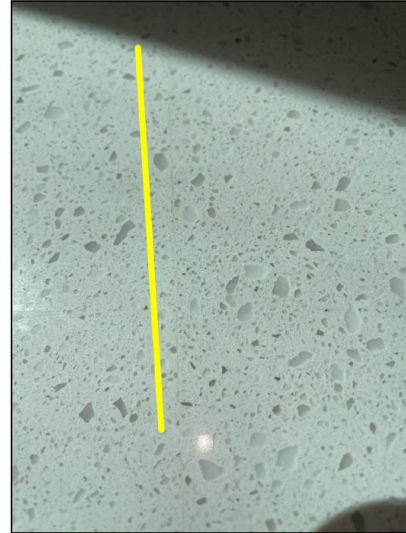
## 1. Counters

Kitchen counters were new and in good condition.  
All cabinet doors functioned as designed.  
Microwave, stove top, and oven all functioned as designed.

Counter top seam noted. Slight roughness when touched. This is typical of joinery of various pieces of counters.

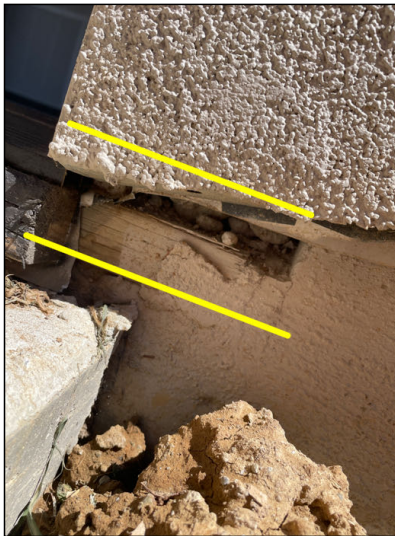
## 2. Exterior Door

Open gap at outside of garage exit door. Repair was not completed and fully mortared and painted. Bare wood exposed. Recommend mortar, paint, and seal by builder as necessary to prevent insect, rodent, and water intrusion.

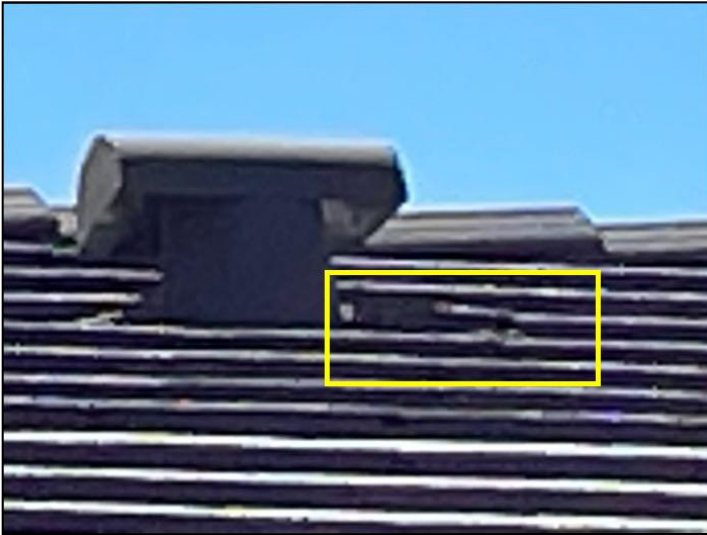
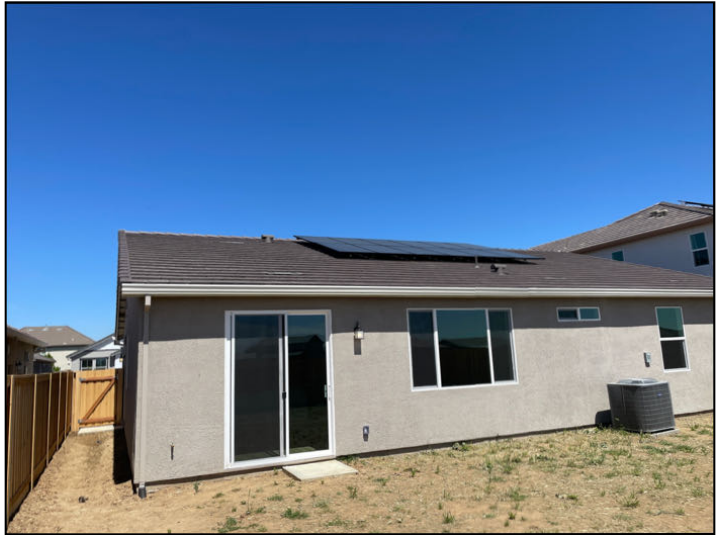
Roof tile on north side of the structure near an exhaust vent appears to be raised and not properly seated. Recommend builder check and repair as needed.

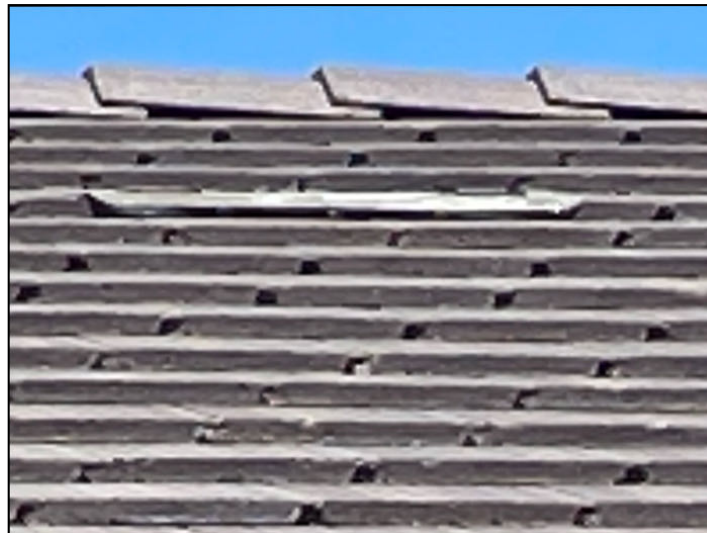
O'Hagin vent not properly painted. This can cause the unit to rust and shorten the lifespan. Recommend builder paint this vent again and inspect other roof penetrations for proper painting and repair as necessary.

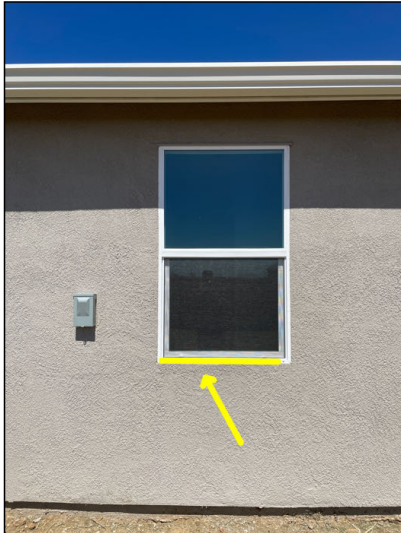
Window on south side not caulked and sealed at the bottom.

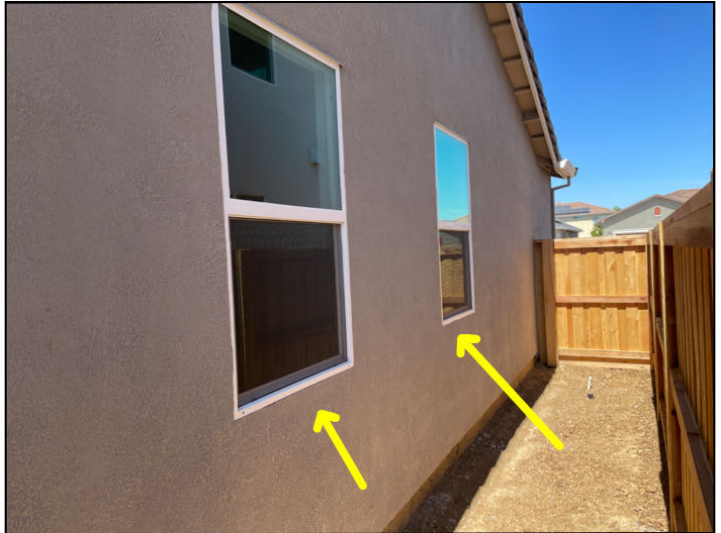
Windows on the east side of the home are not fully caulked and sealed at the bottom. Suggest further review by the builder to ensure all the windows on the exterior are fully caulked and sealed.

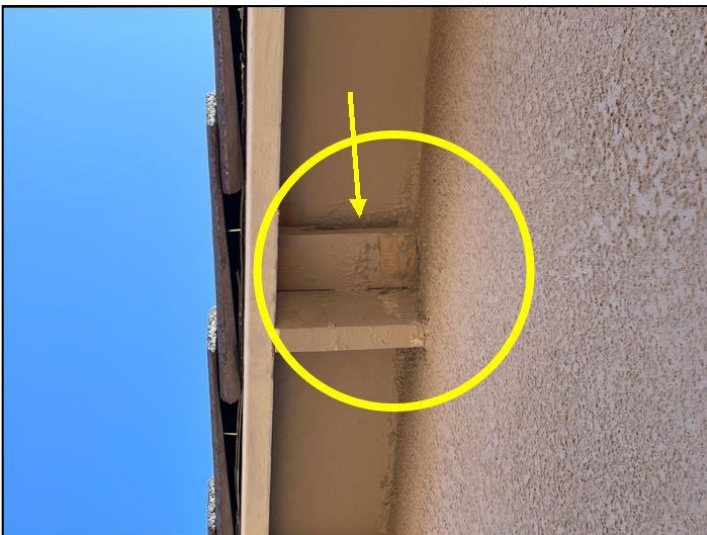
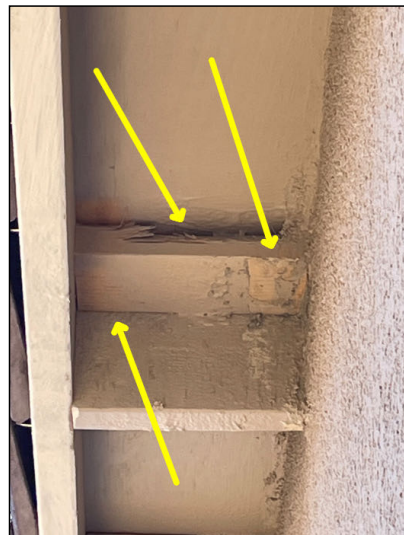
Eave boards unpainted and large gap. This provides accessibility for rodents, insects, and other nesting fauna. Blowing rain can collect in the open gap and hasten deterioration of board and roof deck, creating larger problems in the future.

See caption in previous photo

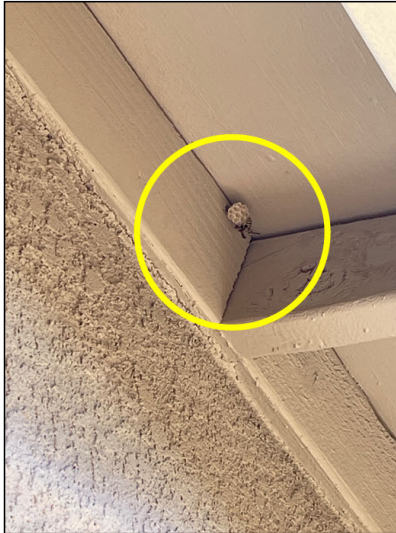
Nesting insects were observed in various locations around the structure in the eaves. Recommend contacting a pest control contractor for regular pest maintenance.

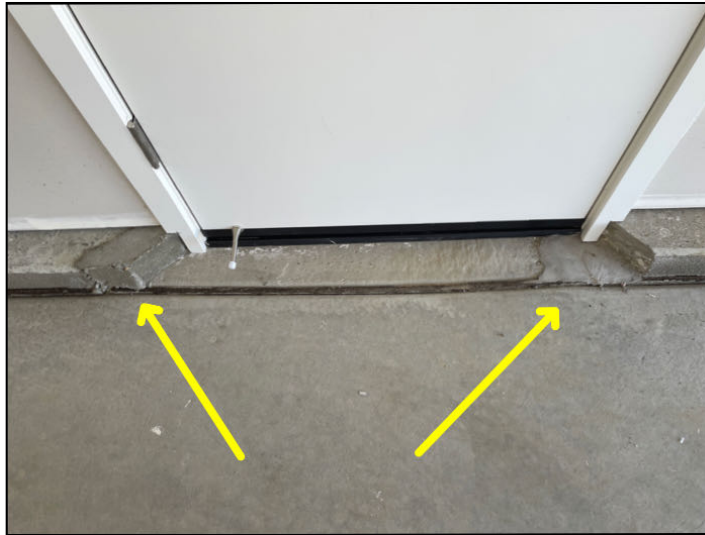
Evidence of repair at foundation wall adjacent to the garage exit door. Refer to photo with gap on outside of exit door. This is possibly related to the repair visible inside the garage. Recommend builder review and make corrections and repairs as necessary to ensure proper seals and function.

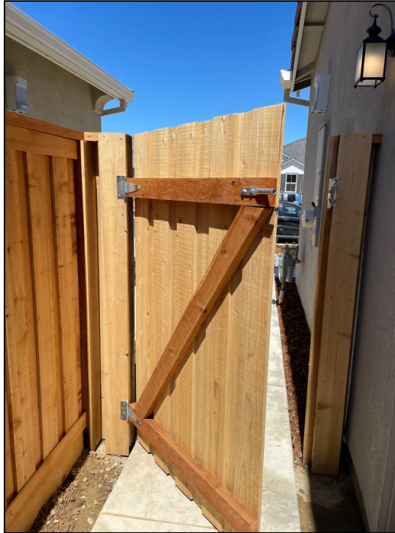
No self-closing/self-latching mechanism on wood gate. This can provide ingress/egress to children and pets and open views from passerby on the street. Recommend installation of proper closing/latching mechanism for safety and privacy.

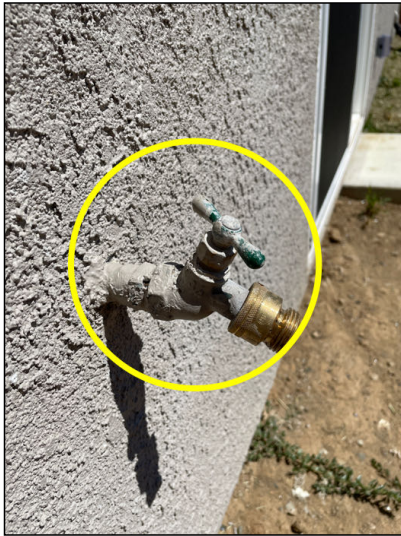
Exterior faucet at the rear of the structure was heavily painted over. This can cause damage to the seals in the fixture and create early failure. Recommend review by builder and repair/replace as necessary.

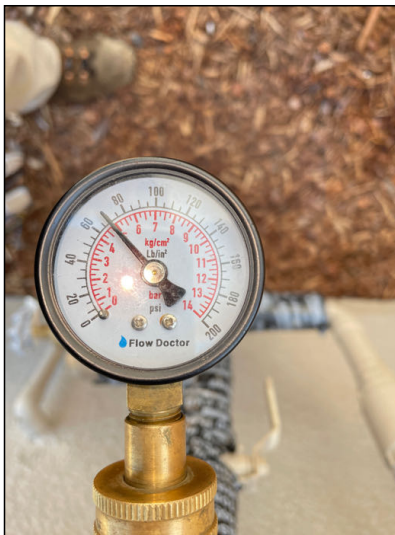
Water pressure at exterior faucet at the northeast corner of the structure showed 70 psi.
