TNCAL Inspections, LLC

Property Inspection Report

, Yuba City, CA 95993
Inspection prepared for:
Real Estate Agent: -

Date of Inspection: 3/2/2024 Time: 10:00
Age of Home: 20 Size: 2690

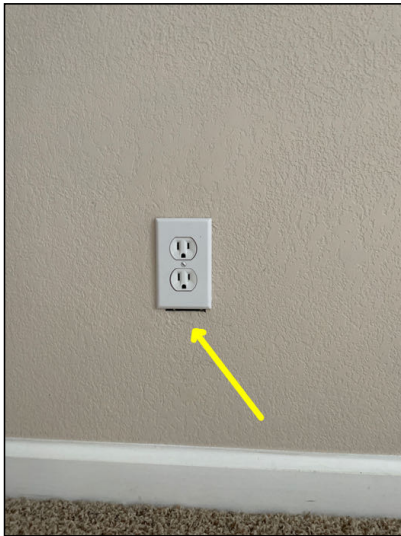
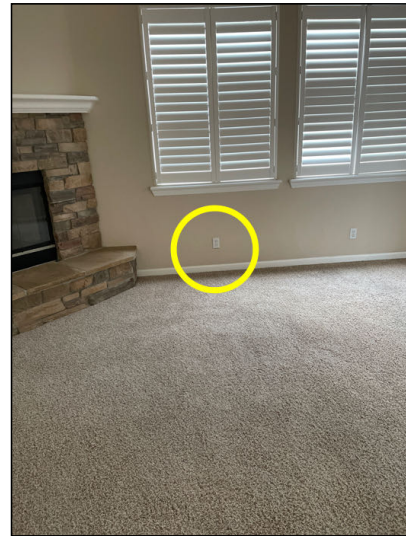
- Loose receptacle

Loose receptacle

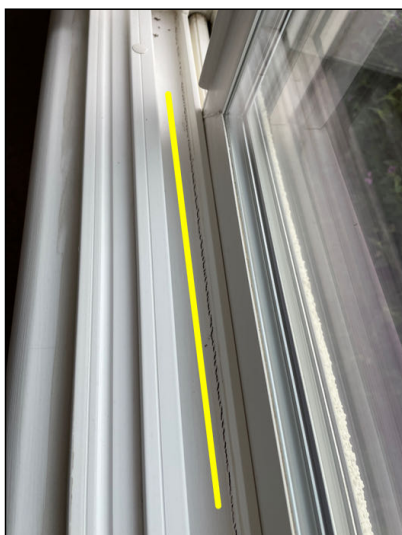
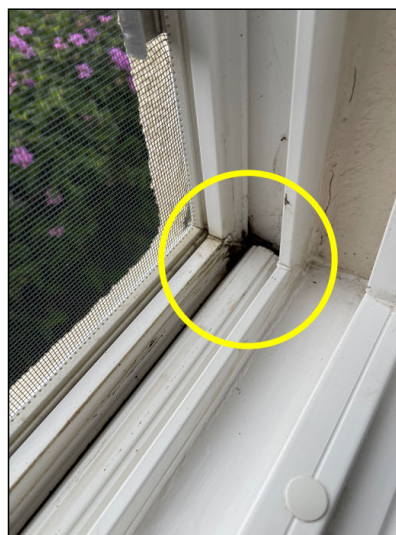
Check all windows and caulk and seal open gaps

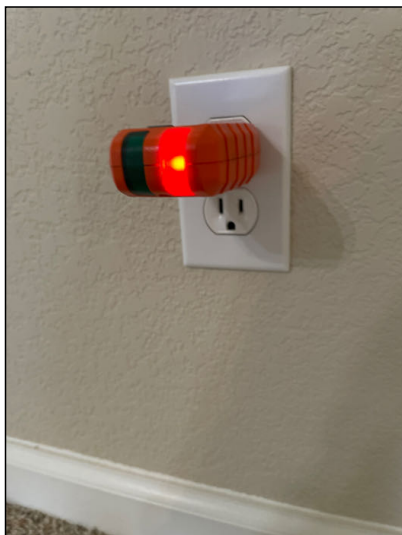
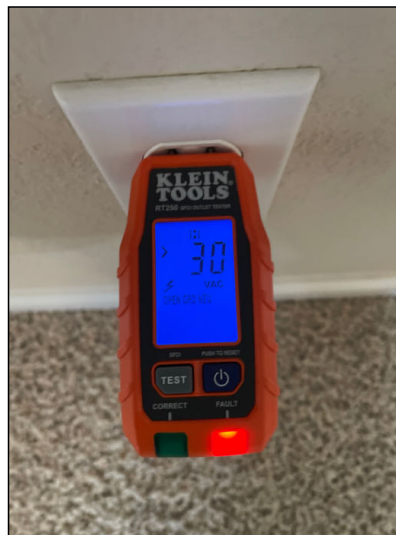
- Open ground - receptacle in wall underneath windows in Living room. Recommend replacement by qualified electrician.

Open Ground showing only on the top portion of the receptacle underneath the window in the living room.

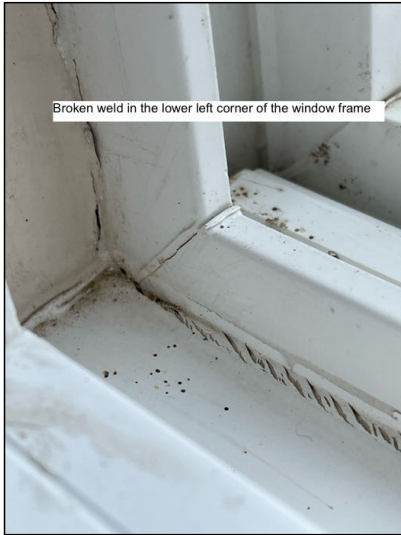
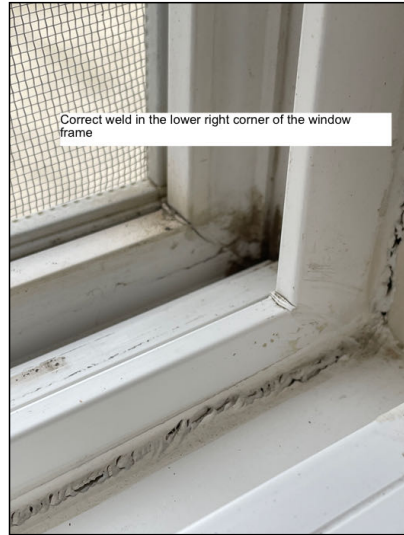
- Broken/cracked frame corners observed. Monitor for further deterioration.

Cracked. Not Correct.

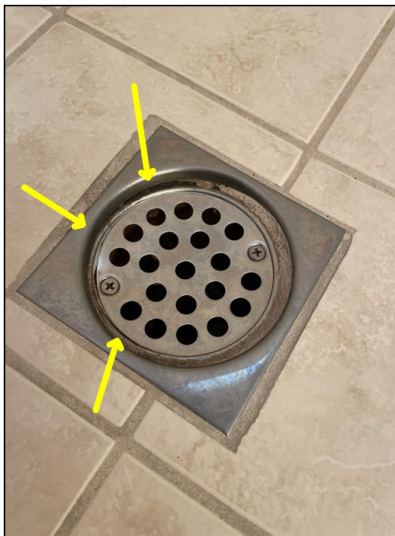
- ****SHOWER BASE****
- functional
- Drain cover is missing grout around the edges of the drain cover. Recommending re-grouting and caulking to prevent leakage.
- Shower drain was slow to drain out the shower. Gurgling noises could be heard as the water was finishing draining out. Recommend clearing the drain with a liquid drain cleaner or with a drain auger.
- ****SHOWER FAUCET****
- Missing grout noted at drain. Recommend maintenance of grout and caulking to prevent water seepage.

Grout needs repair at shower drain.

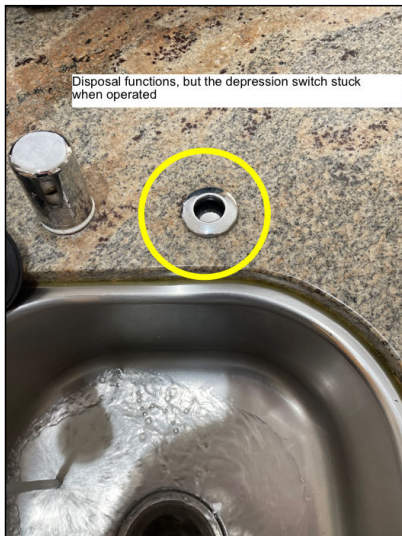
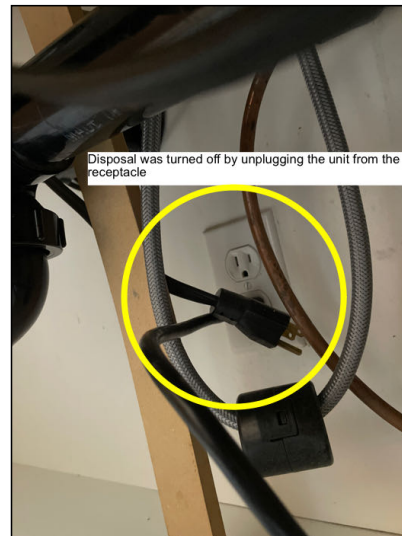
- Disposal On/Off depression switch located to the right of the sink faucet stuck in down/on position when operated. See pictures for descriptions. Recommend repair by licensed electrician to restore disposal to operational status.

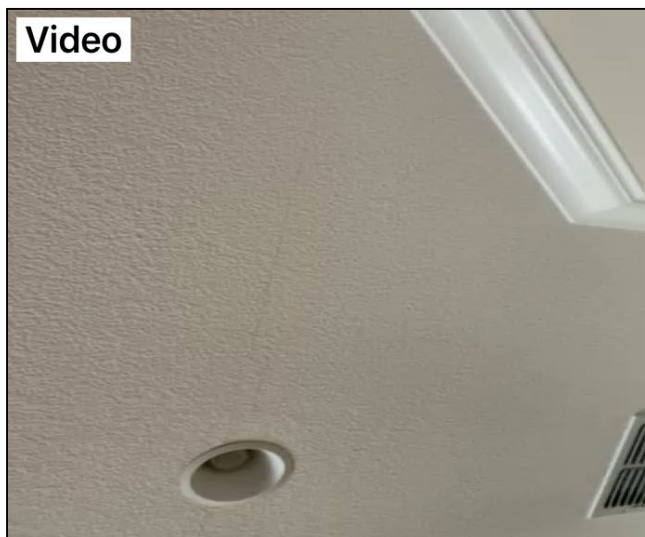
- Crack in ceiling. See Video.

Crack in Ceiling. Another similar crack in Living Room.

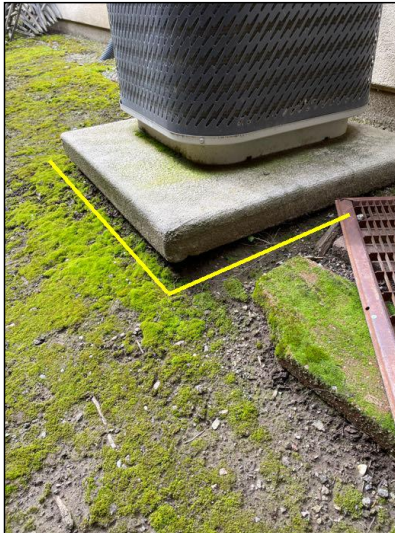
Soil washing from underneath base of AC Compressor on the east side of structure. This will eventually make the base unlevel, which will decrease the lifespan of the compressor unit. Recommend stabilization repair.

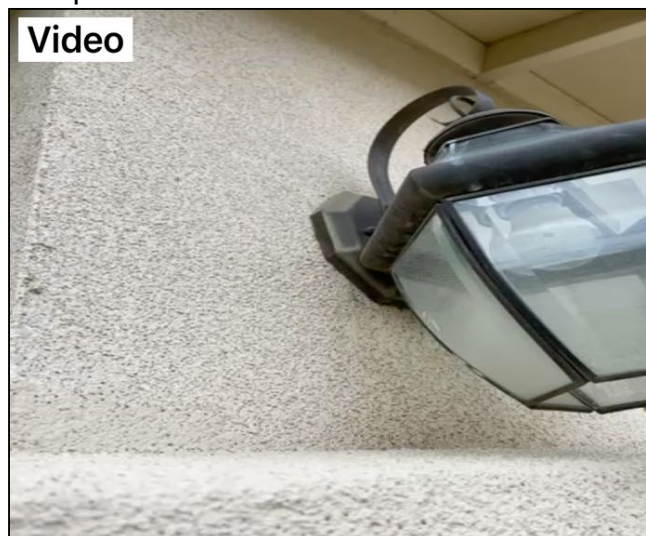
Observations:
• Some loose and improperly installed light fixtures were located. One fixture at the garage did not function due possibly to a bad bulb. They should be installed correctly by a licensed electrician. Once fixtures are correctly installed, caulking around the wall contact areas will prevent moisture intrusion.

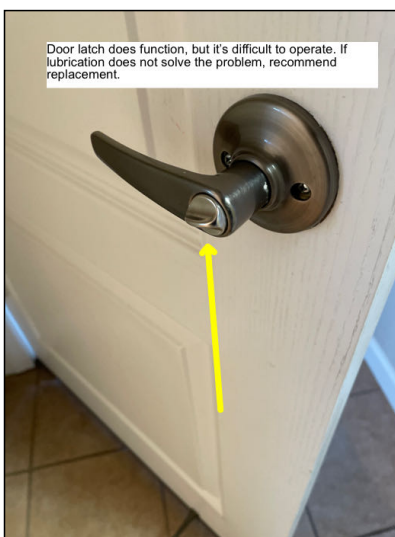
Door handle lock very difficult to operate. This could cause problems exiting the structure in an emergency. Recommend repair/replacement asap.

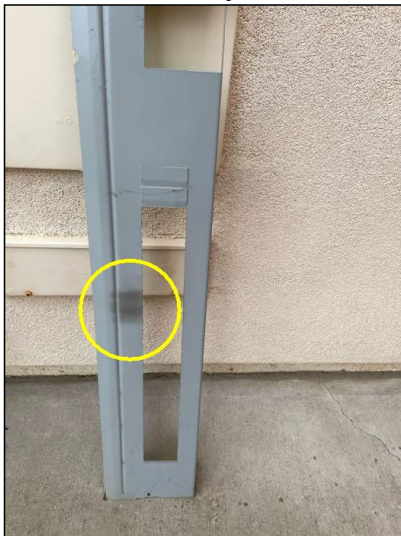
- No major system safety or function concerns noted at time of inspection at main panel box.
- AFCI breakers in the main panel show signs of heating due to heat marks on the back of the dead front panel. These breakers were not overly heated at the time of inspection and they did function correctly. If issues arise due to the breakers, tripping once a load has been placed on them suggest further review for repair or replacement as needed by a licensed electrician

Heat marks from AFCI breakers

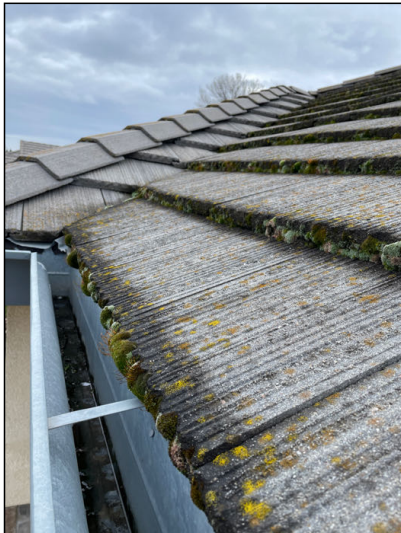
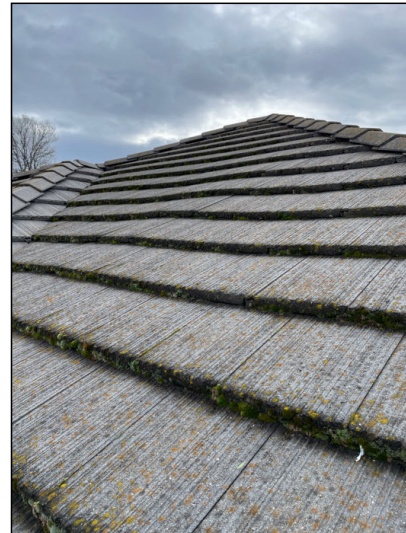
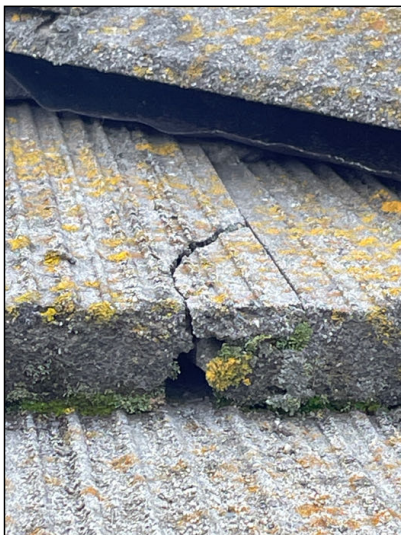
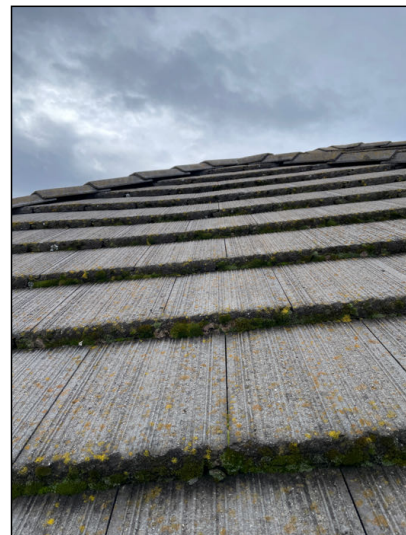
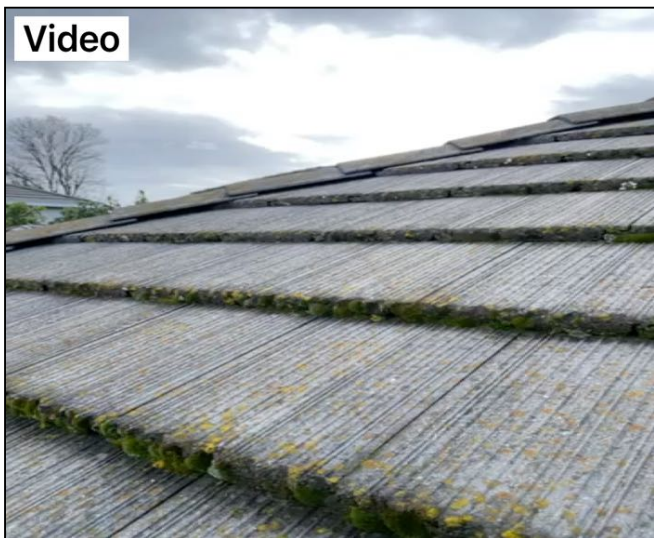
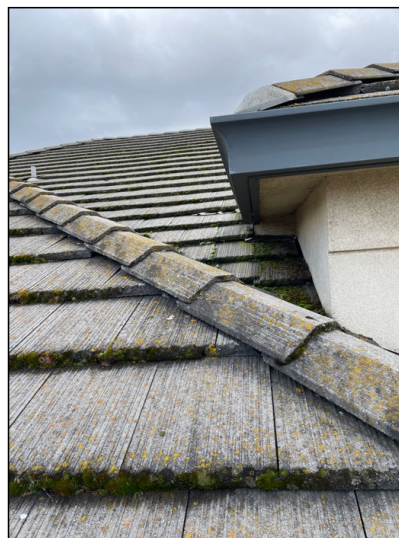
North side of house. Left of roof dormer.

- Clean roof areas: Significant amounts of organic debris evident.
- Moss on roof. This can lead to the premature failure of the roof and subsequent leaks. Recommend treating moss during its growing season (wet months) with a moss killer. For information on various moss treatment products and their pros and cons, visit <http://bryophytes.science.oregonstate.edu/page24.htm>.
- Some areas not clearly visible from inspection level.
- Several chipped/cracked tiles observed.
- Recommend roofing contractor to evaluate roofing tiles and moss growth. Repair/remediate as necessary.

• Strongly recommend review of roof tiles, flashing, and gutters by a qualified roofing contractor to determine functionality and water tightness of the roof system. See multiple photos and videos. Repair as necessary.

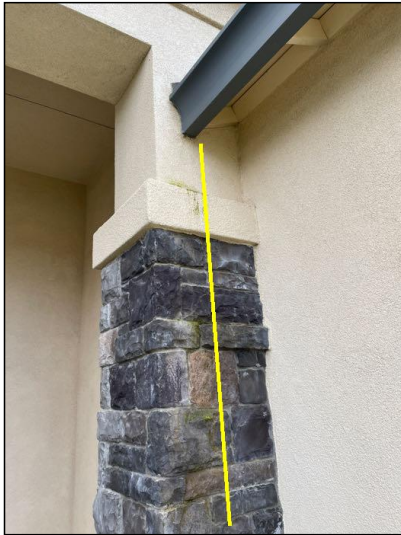
Leaking gutter

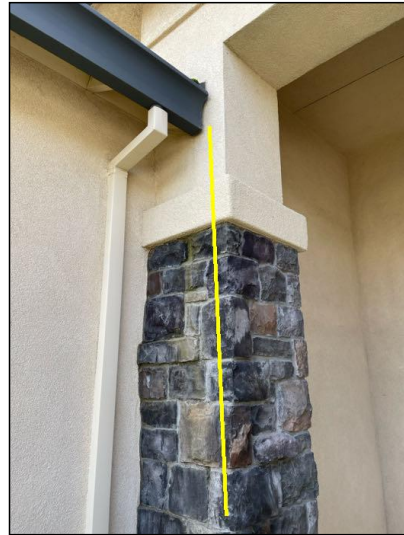
Leaking gutter

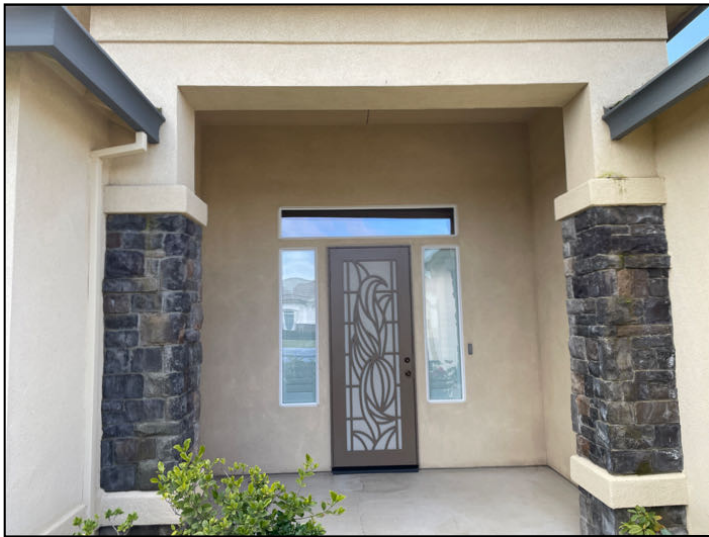
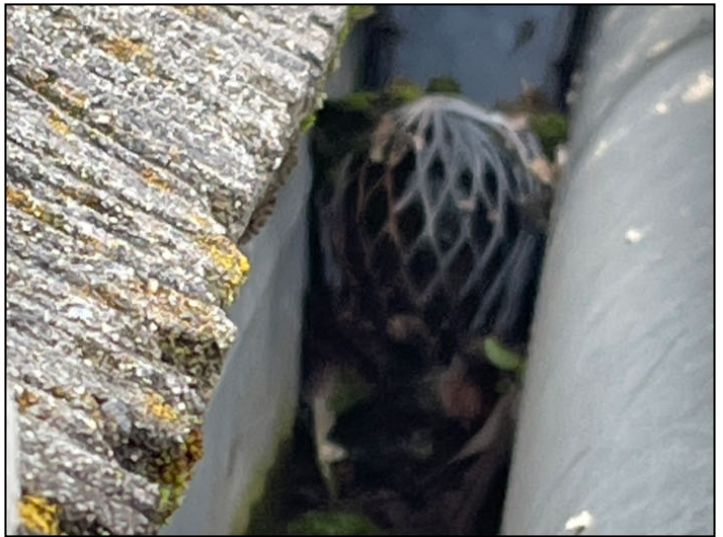
Debris clogging downspout

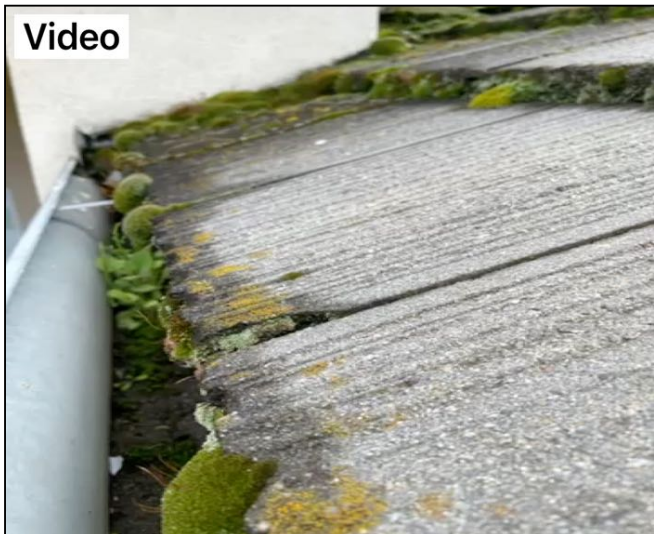
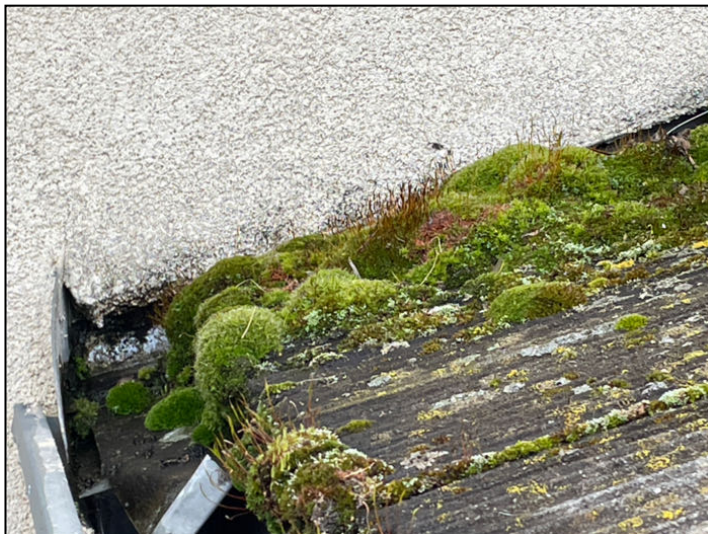
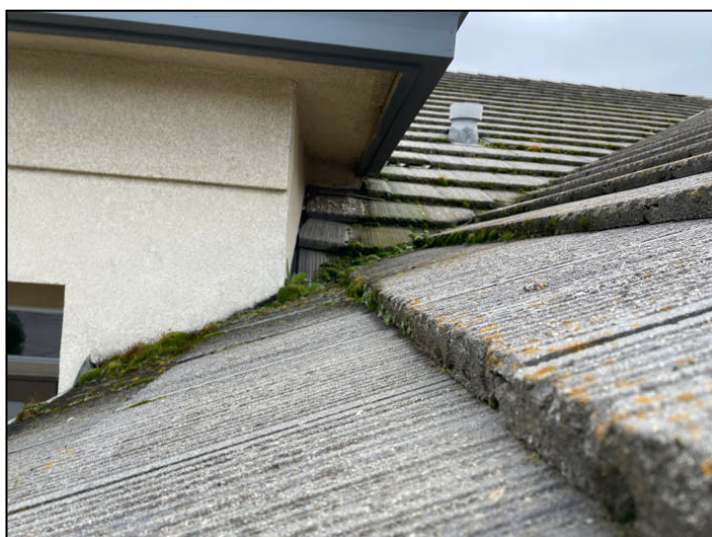
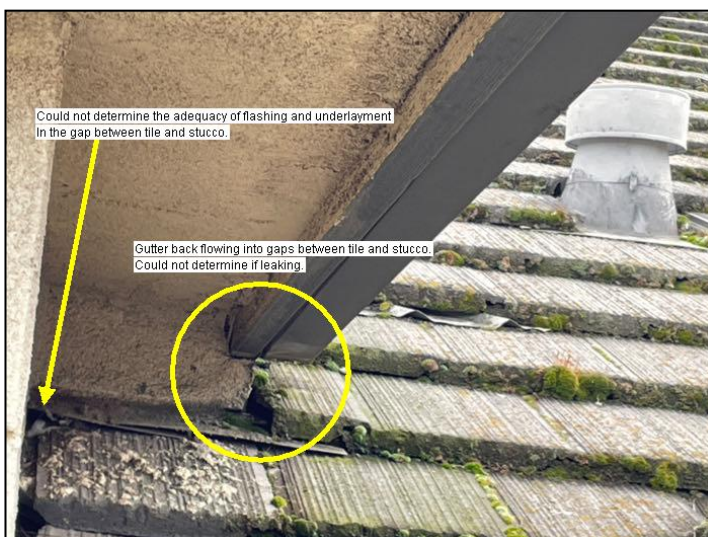
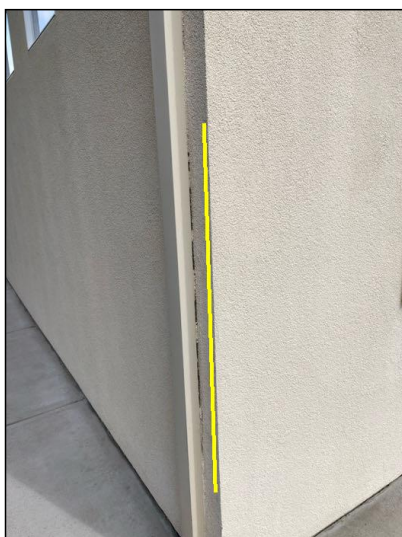
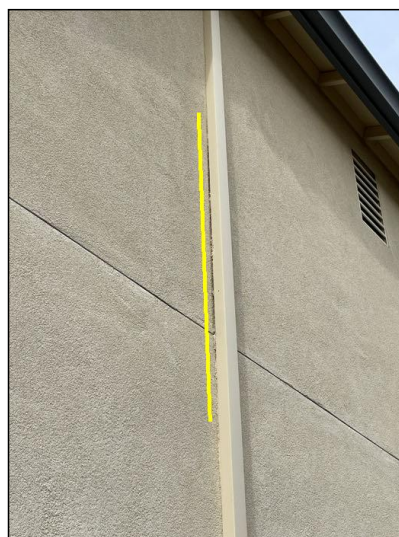
Caulking sealing areas where gutter downspouts contact the stucco walls will prevent moisture intrusion and avoid premature deterioration to siding.

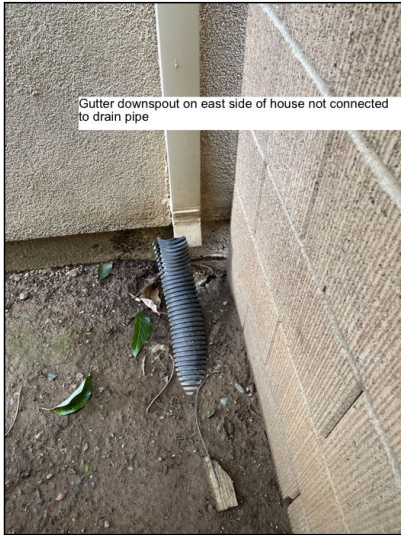
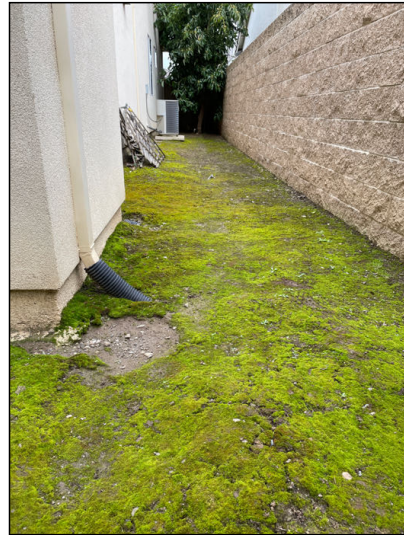
Several gutter downspouts are not properly connected to the underground drain system. The water that comes from the downspouts can pond in enclosed areas, damage soil, and penetrate foundations. Recommend review/repair/reconnection as needed to all gutter drain connections to prevent damage due to excessively wet conditions.

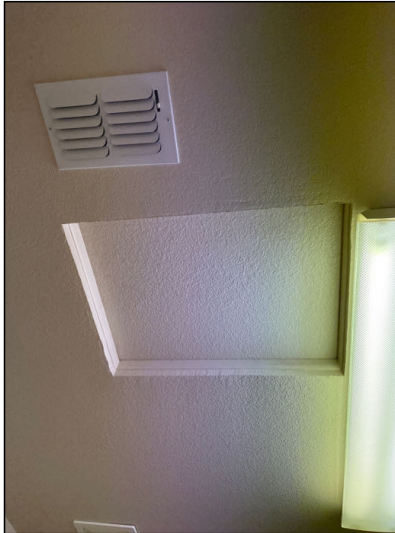
- ****Location of access****
- Scuttle Hole located in:
Laundry room
- ****Access Observations****
- **IMPROVE:** The attic access is not insulated. Expect some energy loss through convection. Recommend insulating attic access hatch cover@@pull down ladder@@ with a batt of fiberglass insulation to reduce energy expenses. See diagram for detail.

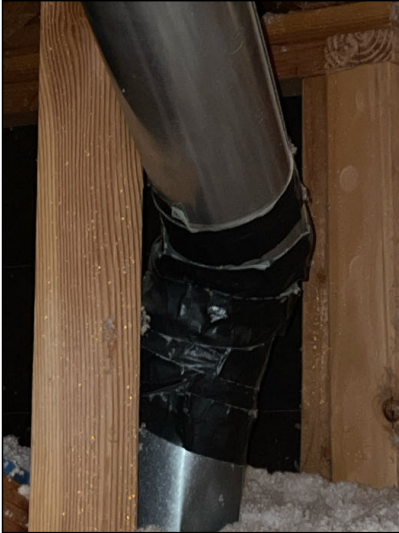
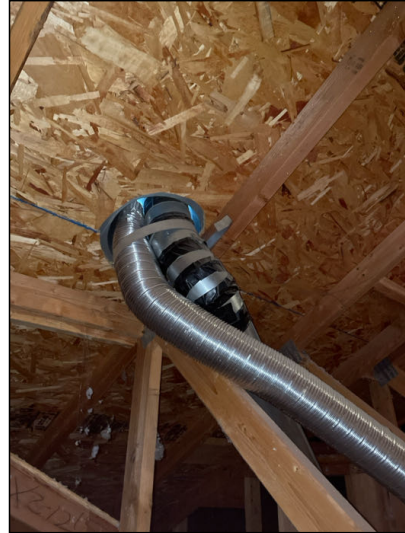
Incorrect taping material utilized to join vent connections for dryer vent. Recommend removal of tape and correct joining of vent piping.

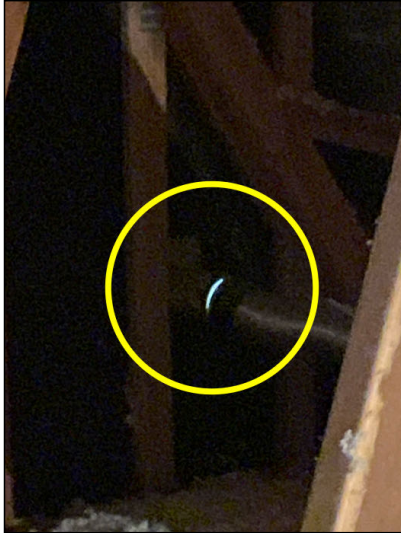
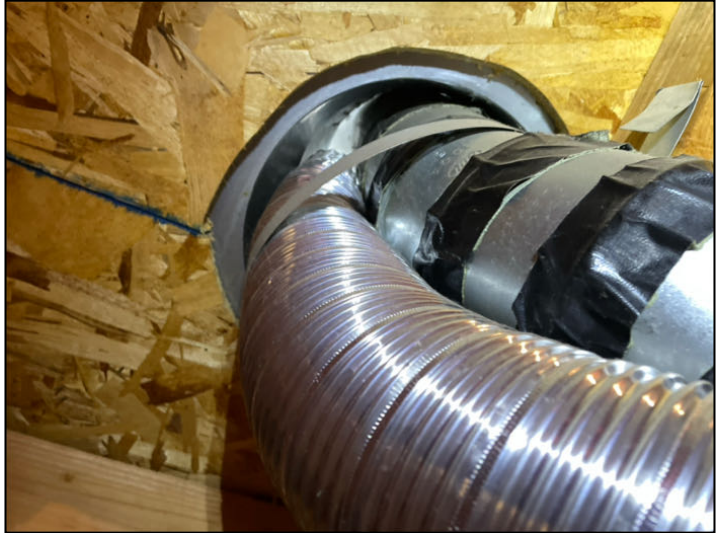
- Bathroom, two exhaust piping is partially disconnected as it penetrates the sidewall of the house. This will result in direct, venting into the attic, and can create moisture problems from venting steam from the shower in the bathroom directly into the attic. Recommend reconnecting and ceiling with proper taping materials.
- Dryer vent exhaust piping incorrectly, wrapped with duct, tape, tape material, similar to gorilla tape. This is an incorrect connection and sealing method. It can cause leaking, and when heated, the joints could come apart, resulting in the dryer venting directly into the attic. Recommend removal of this type and installation of proper sealing materials.

Bathroom, two exhaust piping is partially disconnected as it penetrates the sidewall of the house. This will result in direct venting into the attic and can create moisture problems from venting steam from the shower in the bathroom directly into the attic. Recommend reconnecting and sealing with proper taping materials.

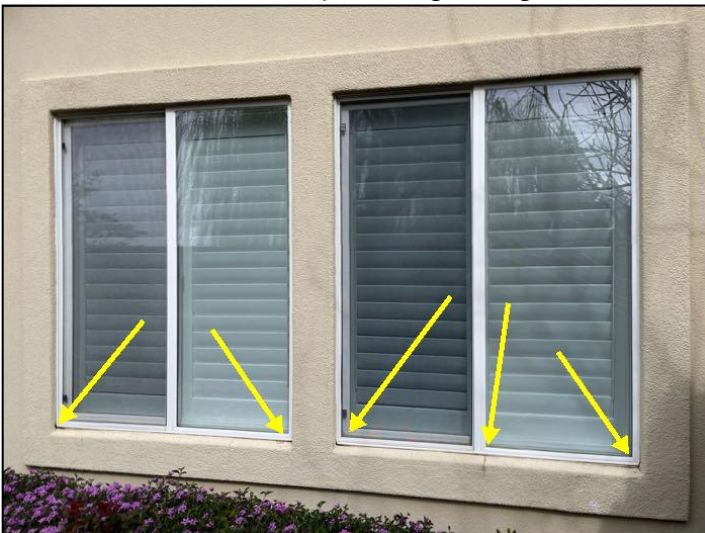
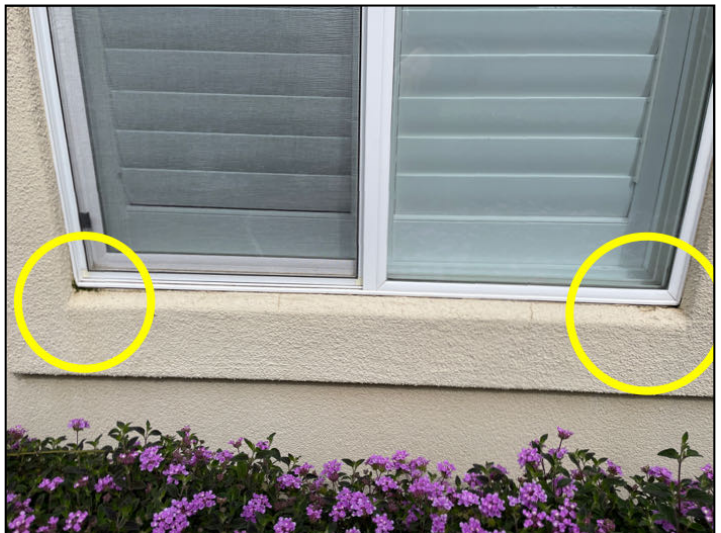
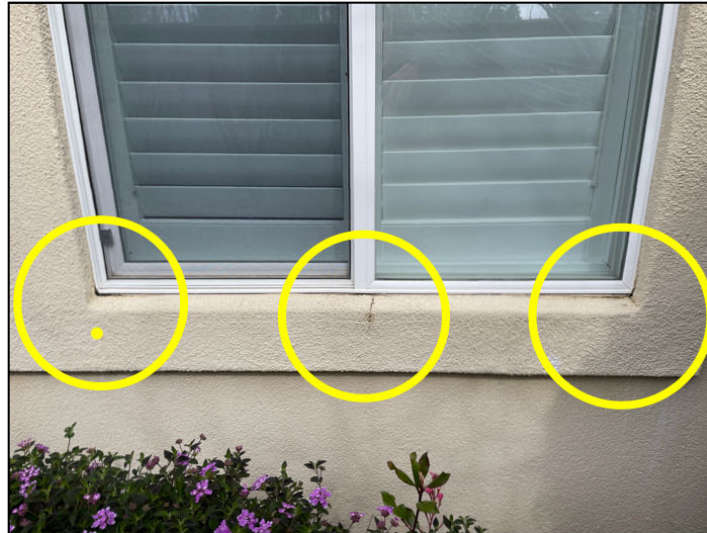
Recommend review of exterior of all windows for general maintenance to clean and seal cracks and remove any organic growth. This will prevent moisture and insect intrusion and avoid premature deterioration of the windows and surrounding framing and stucco.

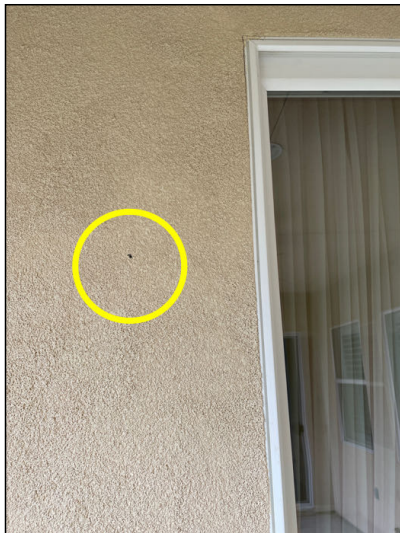
Recommend sealing this hole to prevent moisture and insect intrusion.

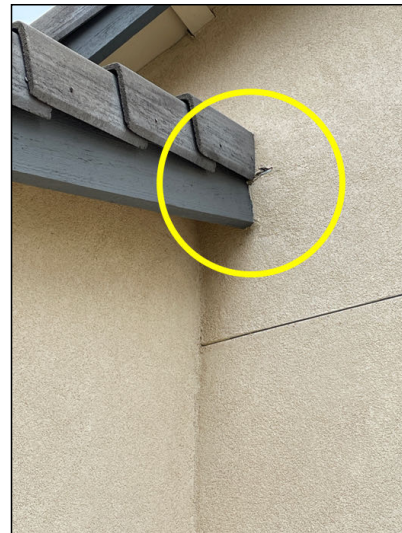
This area of the stucco on the west side of the structure at the edge of the roof shows signs of swelling. This could be the result of water penetration in the observed opening. Due to the rainy weather on the day of inspection, thermal imaging was unable to provide additional information to support any conclusion. Recommend review and evaluation by a qualified professional (roofer, stucco pro) to determine the extent of any water penetration and repair as necessary.

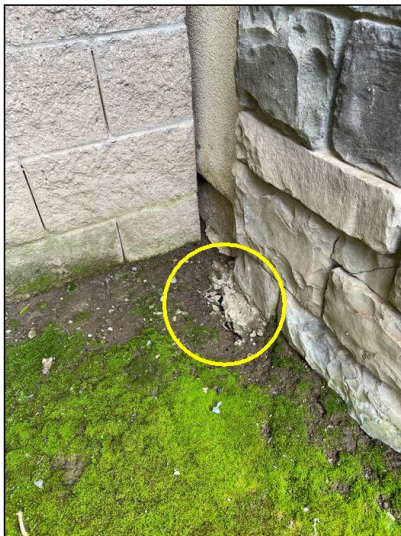
Dirt washing from footer for rock siding. This is possibly due to the gutter downspout on the other side of the wall being disconnected from the drain line and ponding water running through the opening between the wall and the slab foundations.

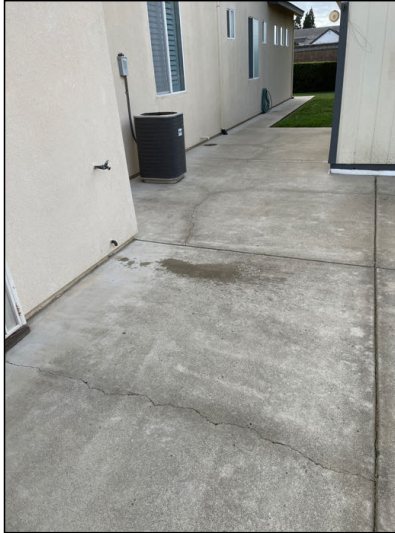
Example of typical cracking of concrete. This exists at various locations and is not structural in nature.

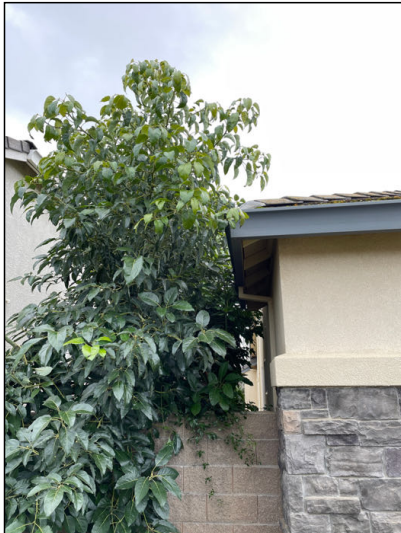
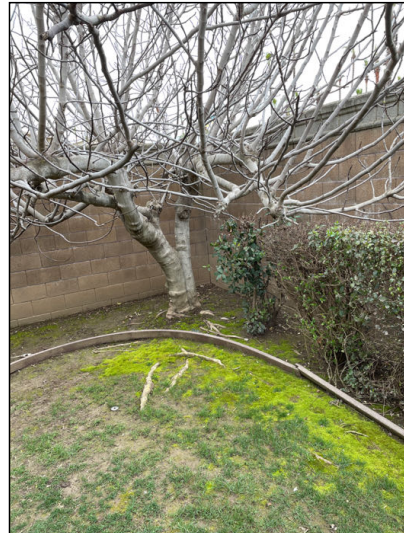
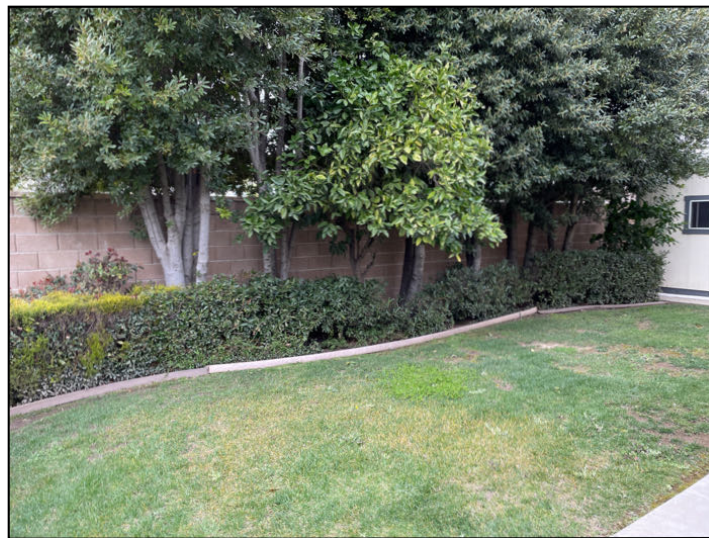
- Prune or remove any plants that are in contact or proximity to home to eliminate pathways of wood destroying insects.
- Tree limbs within 10 feet of roof should be trimmed away to provide air and sunlight to roof, while minimizing debris & dampness.
- Trim trees that are in contact or proximity to home, as branches can abrade roofing or siding.
- Maintenance Tip: When landscaping, keep plants, even at full growth, at least a foot (preferably 18 inches) from house siding and windows. Keep trees away from foundation and roof. Plants in contact or proximity to home can provide pathways for wood destroying insects, as well as abrade and damage siding, screens and roofs.

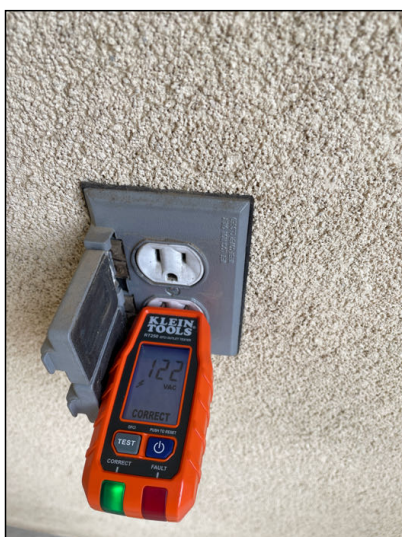
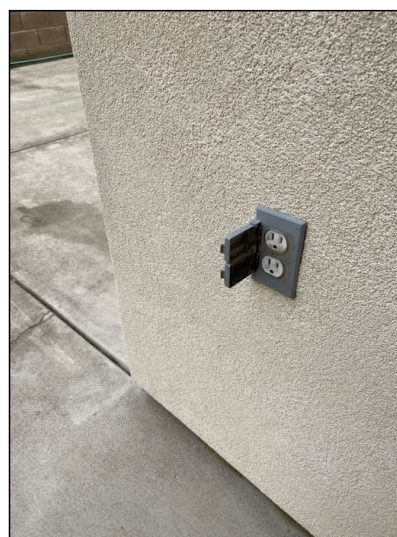
- Weatherproof outlets—Exterior outlet / switch cover(s) not waterproof based on current standards and several covers are missing foam seals. Have certified electrician evaluate and repair as necessary.

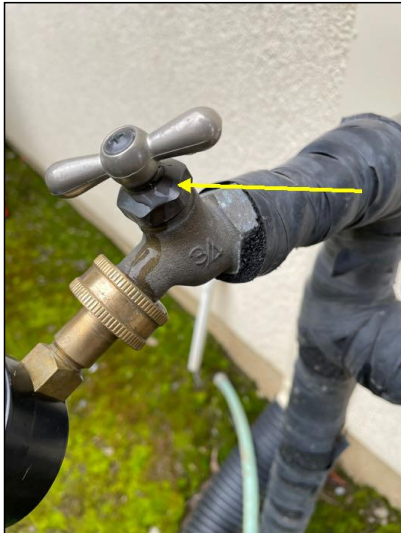
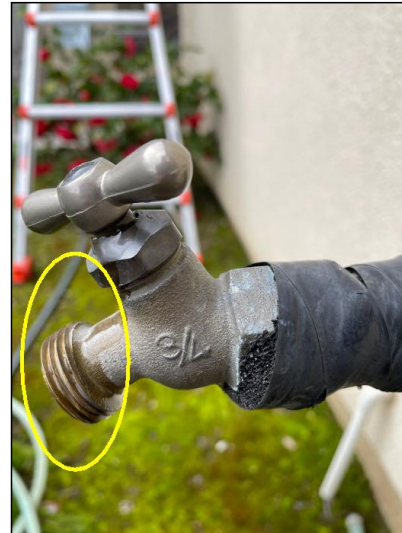
Location: North side of house. • East side of house. • West side of house.
Observations:
• Hose bib at north side of house leaks.

Leaking valve at outdoor spigot near front door.
