TNCAL Inspections, LLC

Property Inspection Report

, Yuba City, CA 95993
Inspection prepared for:
Real Estate Agent: -

Date of Inspection: 3/2/2024 Time: 10:00
Age of Home: 20 Size: 2690

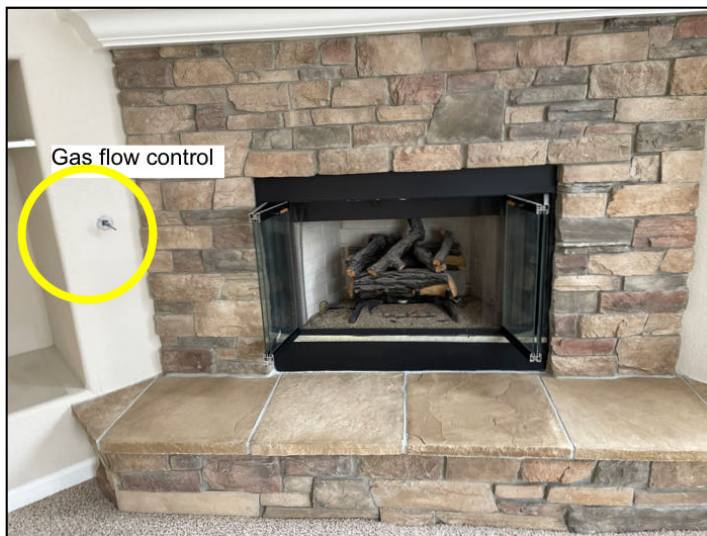
- Older model gas fireplace. No electronic ignition. No pilot light observed. Appears to function by using a provided gas key to turn on the gas and then igniting the fire in the firebox. Fireplace gas and ignition was not tested.

- Have a gas fireplace professional service/evaluate fireplace before operating.

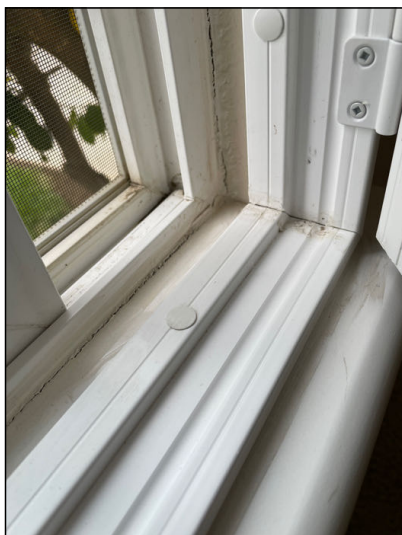
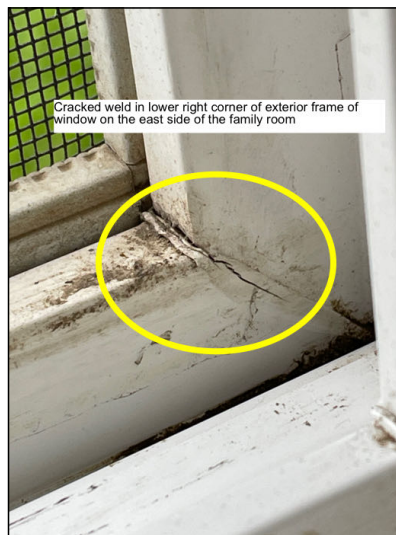
FR

Check all windows and caulk and seal open gaps

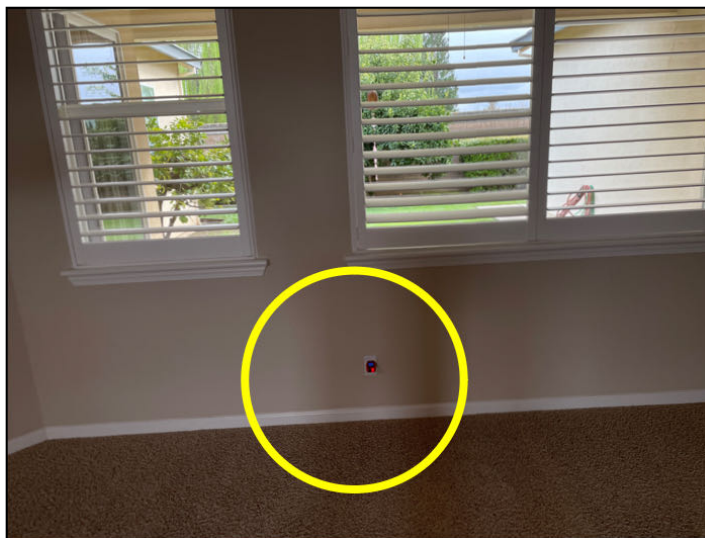
- Open ground - receptacle in wall underneath windows in Living room. Recommend replacement by qualified electrician.

Open Ground showing only on the top portion of the receptacle underneath the window in the living room.

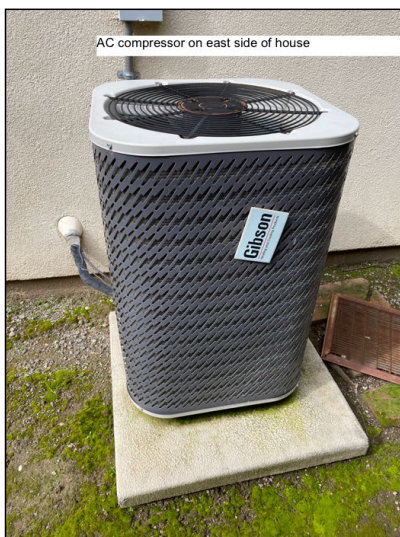
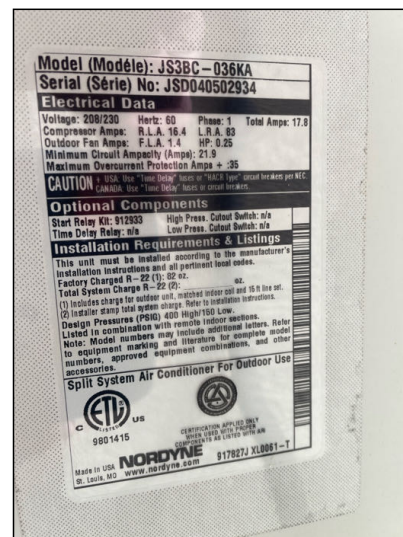
- There was no data plate visible on the AC Condensing unit on the west side of the structure. The furnaces in the attic were sealed and the data plates were inaccessible. The data plate from the AC Compressor unit on the east side of the structure was visible. This unit is a Nordyne AC Condensing unit manufactured in May 2004. *Assuming* that the AC Condensing units and the furnaces in the attic were installed at the same time, each of these units would be 20 years old. AC Condensing units have an expected design life of 10-15 years. The design life for forced air furnaces is 15-20 years. These numbers are industry average service design life expediencies. *Assuming* the manufacture dates located are the same for all units in the HVAC System, these units are at or beyond their expected service life expectancy. Proper routine upkeep/maintenance, regional climate, and placement of the mechanical systems will all affect the longevity of the systems. Outdoor temperatures prevented operation of the AC Units for the inspection. These units appeared functional at the time of inspection. The furnaces were functioning well during the inspection. Recommend further, detailed inspection by a qualified HVAC contractor for a complete system review. Also recommend budgeting for replacement as needed.

Data Plate from AC Condenser on east side of structure.

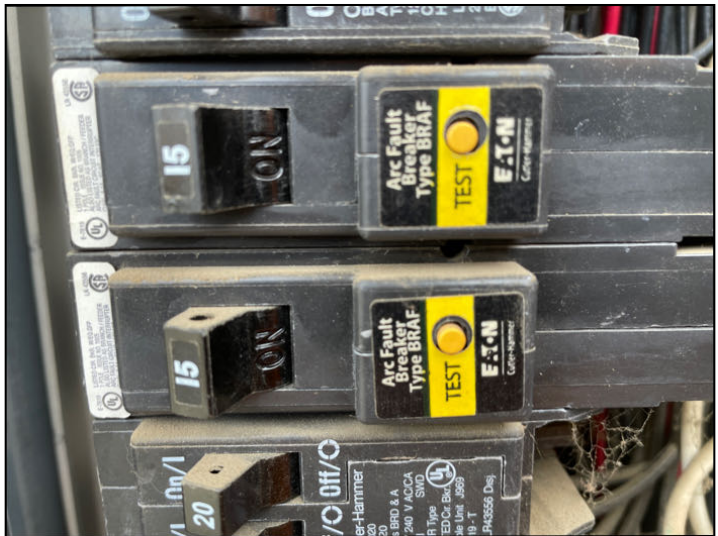
AFCI Breakers. Tested. Operated correctly.

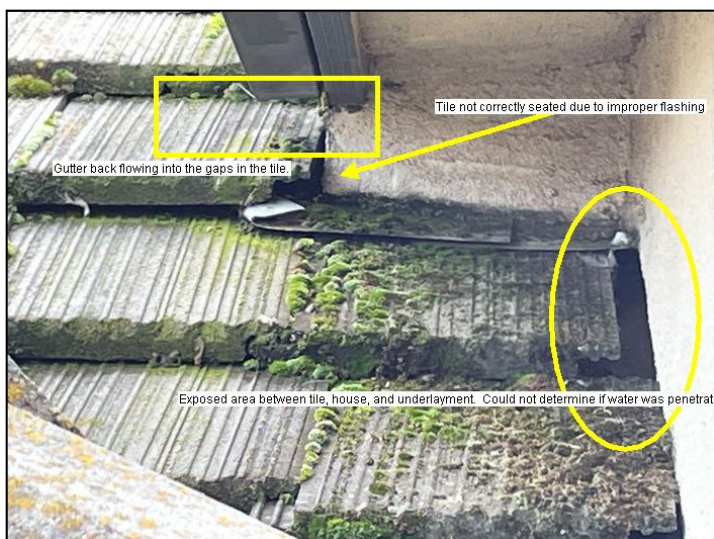
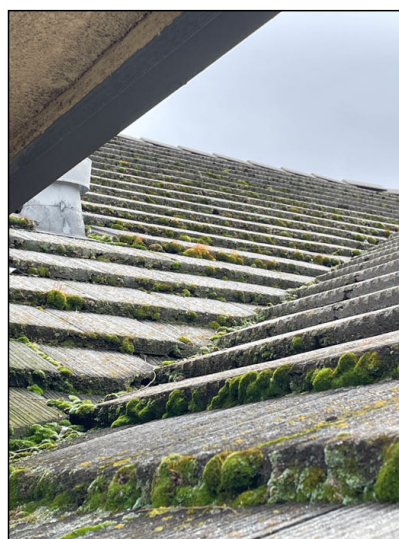
North side of house. Left of roof dormer.

- Clean roof areas: Significant amounts of organic debris evident.
- Moss on roof. This can lead to the premature failure of the roof and subsequent leaks. Recommend treating moss during its growing season (wet months) with a moss killer. For information on various moss treatment products and their pros and cons, visit <http://bryophytes.science.oregonstate.edu/page24.htm>.
- Some areas not clearly visible from inspection level.
- Several chipped/cracked tiles observed.
- Recommend roofing contractor to evaluate roofing tiles and moss growth. Repair/remediate as necessary.

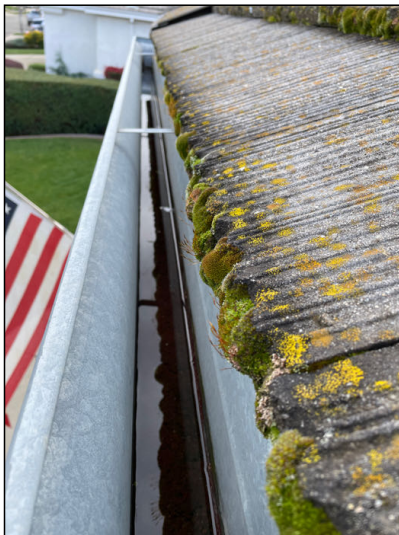
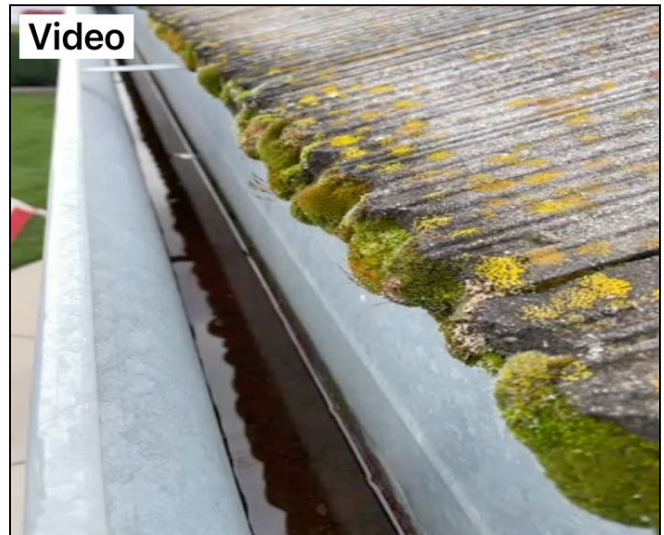
- Gutter leak(s) noted. Repairs recommended. See photos and videos.
- Clean gutters: Significant amounts of debris evident.
- Several downspouts of the roof gutter system are not properly connected to the drain lines. They are discharging against the foundation walls. Downspouts should discharge at least 6 feet away from the side of the foundation or be connected to drain lines that lead to a storm water drainage system.
- **Strongly recommend review of roof tiles, flashing, and gutters by a qualified roofing contractor to determine functionality and water tightness of the roof system. See multiple photos and videos. Repair as necessary.**

Leaking gutter

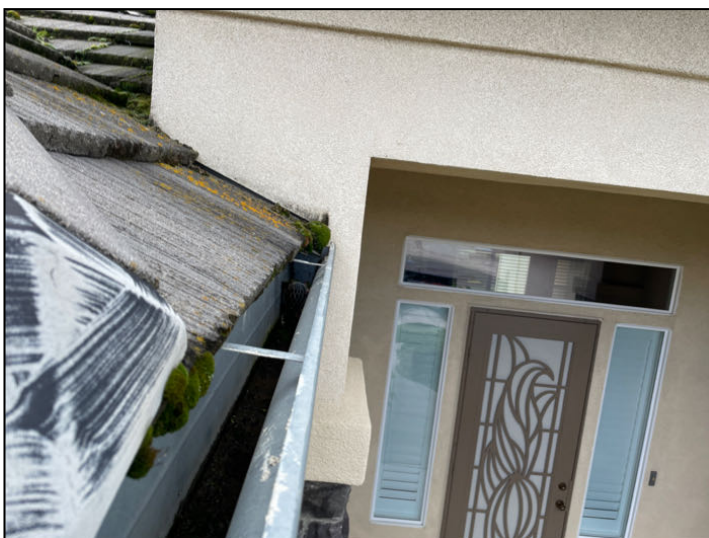
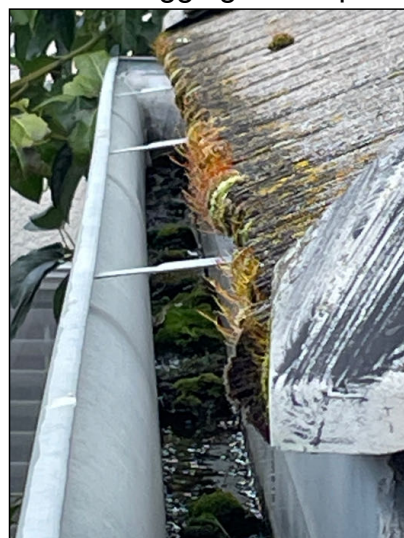
Video

Debris clogging downspout

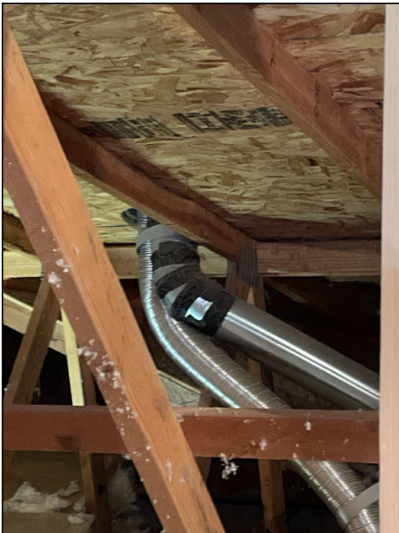
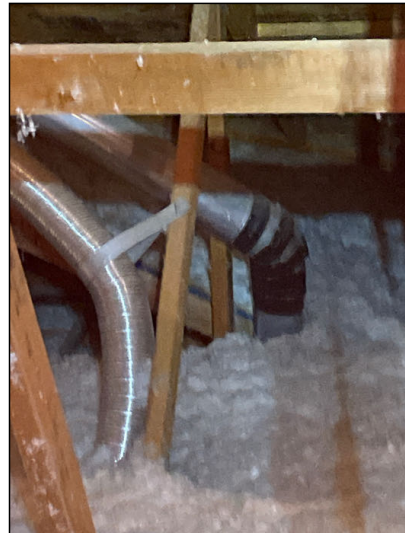
Incorrect taping material utilized to join vent connections for dryer vent. Recommend removal of tape and correct joining of vent piping.

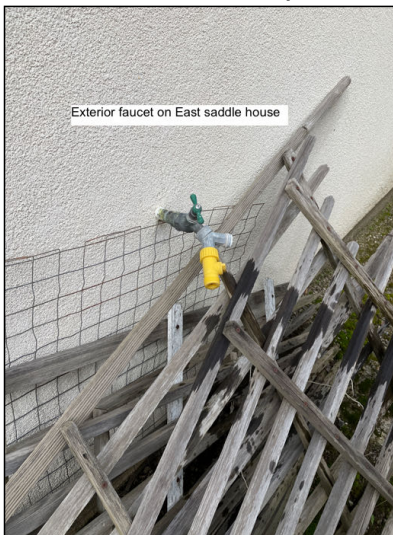
Leaking valve at outdoor spigot near front door.

No pressure relief valve on all outdoor spigots.

Recommend removal/relocation of extraneous materials to avoid damage to stucco, faucet, and prevent insects.
